Glenview Park District 2019 Tree Inventory Update

Prepared By:
Leslie Delles, ISA Certified Arborist # IL 9199-AM TRAQ
December 12, 2018

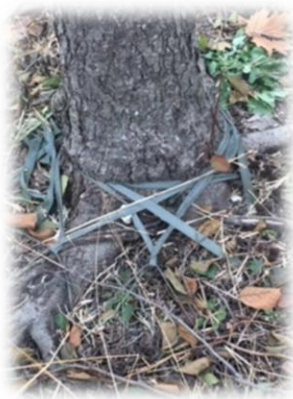
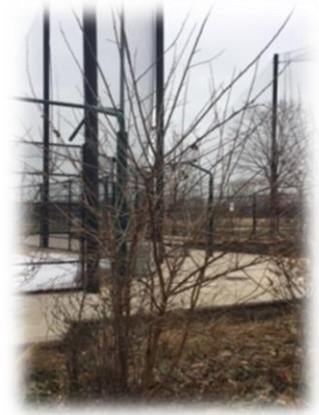
Community Park West was completely updated this year and all trees were remeasured for DBH. New data was also collected for canopy height and spread, as well as degree of wounding, decay, and deadwood. Changes in condition or maintenance status were also updated. The young tree population at Community Park West remains in overall good condition with few significant changes since last year. A small number of new observations made this year are as follows. In the raised planting beds near the southern ball fields, a few Mulberry volunteers (see right) have sprouted and considering the high traffic nature of this area during the warmer months, we encourage the removal of these sprouts before they become larger. Also, a number of the Alder trees along the south side of these ball fields are suffering basal damage from straps that appear to have been present since the trees were planted (see left). If possible, GPD should consider removing these girdling objects. As previously mentioned during last year's update, Ash and Cottonwood volunteers have sprouted around the perimeter of the southern playground. Cottonwood trees are known for being fast growing, but weak wooded trees and their proximity to the playground could lead to the potential for risk in the future. On that same note, the Ash sprouts are developing with poor form and their potential for continued EAB infestation could create future issues as well. GPD might consider the preemptive removal of these volunteers before their size and cost of removal increases. Some of the younger trees at CPW are quite small and have a low branching habit. These trees should receive proper establishment pruning so that good architecture develops as they grow. The treated Ash trees at CPW are in good to fair condition and continued treatment is recommended. The remaining untreated Ash trees have varying levels of EAB damage and should

be monitored for decline and removed if and when necessary. The middle-aged Baldcypress trees on the north side of the park continue to thrive, growing along the edges of the low-lying areas and one of them has been moved to the condition 1 category this year since it has met the 16" DBH threshold and has excellent architecture. As mentioned in past reports, there is an opportunity for woodland restoration in the area on the northeast side of the dog park. There is certainly open planting space in the dog park where dogs and their owners would benefit from some shade in the summer months. Any tree species chosen for planting in the dog park should be tolerant of the extra nutrient loading that likely exists in the soil.

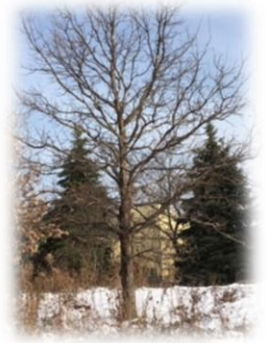
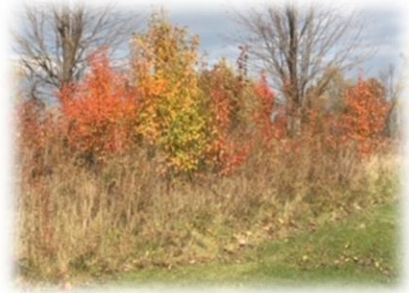
Gallery Park was completely updated this year and all trees were remeasured for DBH. New data was also collected for canopy height and spread, as well as degree of wounding, decay, and deadwood. Changes in condition or maintenance status were also updated. We are happy to report that some of the trees at Gallery have moved into the condition 2 category this year due their good condition and their surpassing of the 8” DBH threshold. Most of the younger trees planted at Gallery in recent years have established well and continue to thrive and we expect that many of these will move into the condition 2 category as well (see right). The treated Ash trees continue to be in good to fair condition, however the remaining untreated

White Ash trees in the managed areas of the park have sustained EAB damage and may require removal. We were also pleased to see that the many Ash resprouts have been removed. The newly planted trees throughout the park are a great example of GPD’s commitment to improving diversity. We look forward to seeing the young Shagbark and Pecan Hickory trees establish well and grow with vigor. Lastly, we observed a significant number of Callery Pear tree volunteer sprouts at Gallery (see left). In our region, and throughout the state, Callery Pear trees are being recognized for their invasive qualities since they spread rapidly and have been taking over open spaces. We encourage GPD to take early action before these Callery Pear sprouts become a significant issue at Gallery Park.
